AR 3201 # 13690

SERVICE BULLETIN AR 3201 - 3/92

SUBJECT : Synthesizer Modules AR 3201

Synthesizer Module 28110 - 13000.000  
Synthesizer Module 28141 - 13000.000

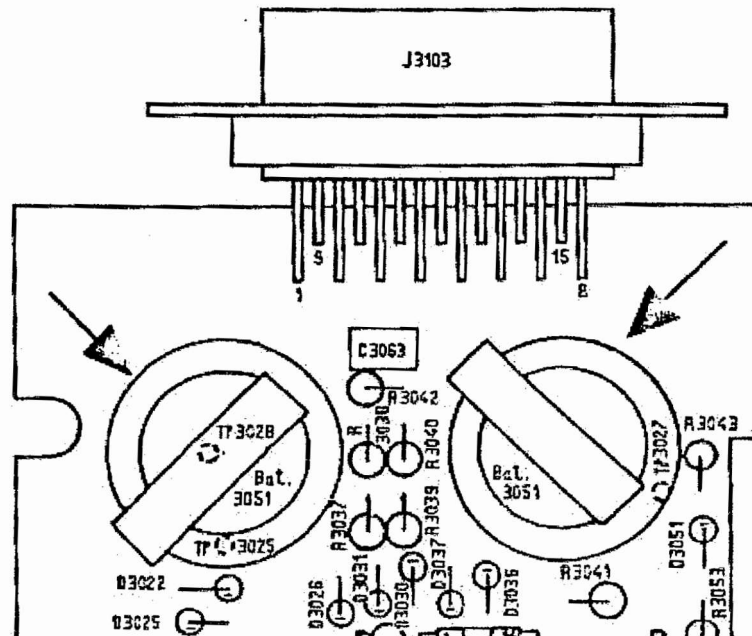
Fig 1: Location of battery Bat. 3051 on Synthesizer Module 28110 - 13000.000

1. Determine manufacturing date of the Ni/Cd-battery. Since 1986 there is a marking on the battery's label (Bat. 3051 and Bat. 3052 or Bat 3001) which describes the manufacturing date.  
For example : 8707 means manufacturing date: 7th calendar week 1987
2. If the batteries are more than 4 years old it is recommended to replace the batteries, even if there is no visible damage.
3. Carefully check the battery connectors and the surrounding components for sediments
4. If there are any damages, remove the battery and surrounding components in order to get access to the contaminated printed conductors for cleaning. Use alcohol (methyl alcohol 94%) and a glass-brush for cleaning. Any component removed should be replaced with a new part.
5. If battery replacement is necessary, insert and solder new batteries as shown in Figures 1 to Figure 5. Ensure correct polarity!

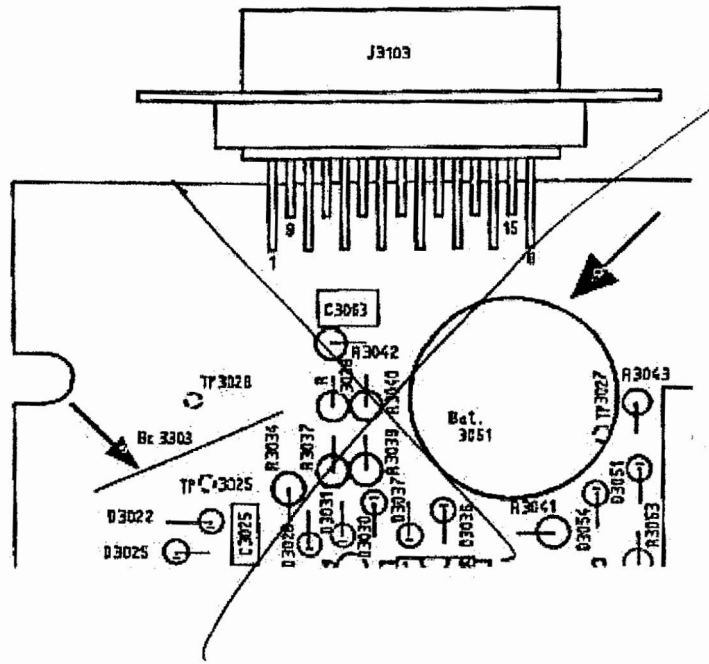
Fig. 2: Location of battery Bat. 3051 on Synthesizer Module 28110-13000.000 Change Index "b"

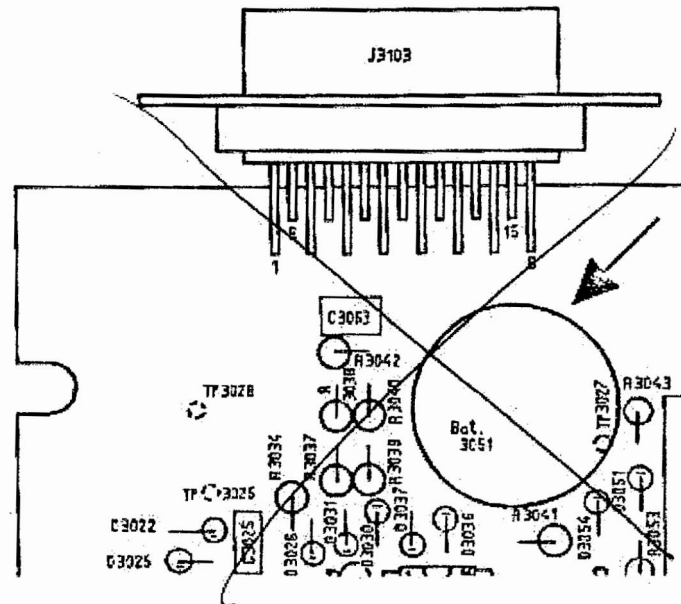
Fig. 3: Location of Bat. 3051 on Synthesizer Module 28110 - 13000.000 (new lay out)

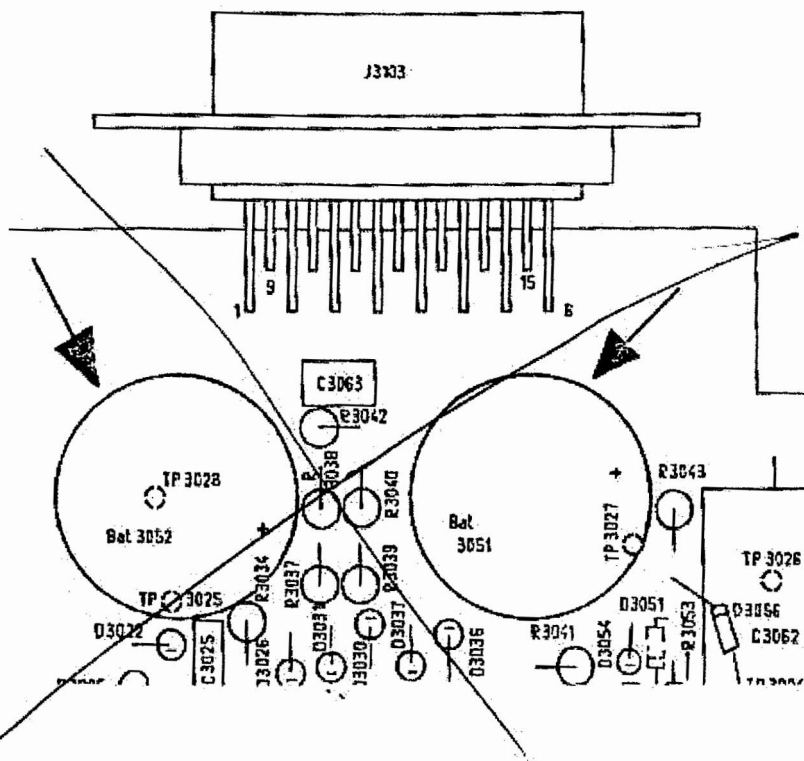
Fig. 4: Location of batteries Bat. 3051 and 3052 on Synthesizer Module 28110-13000.000 Change Index "e"

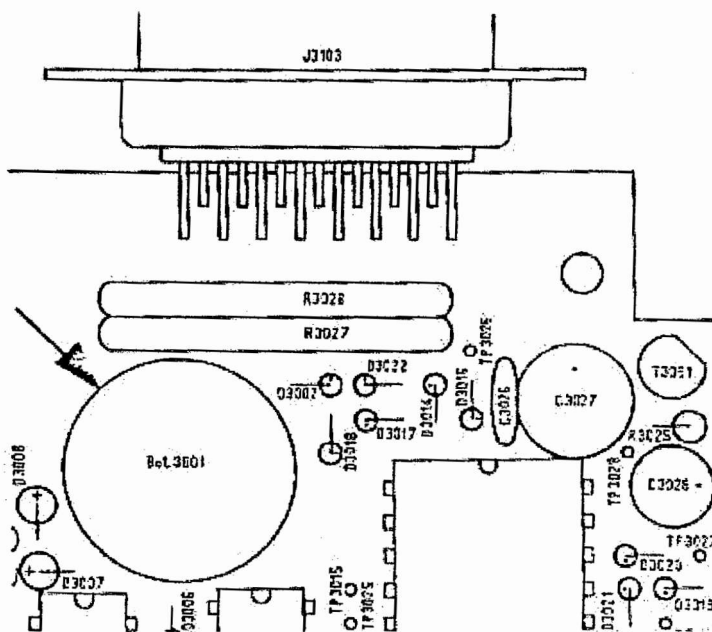
Fig. 5: Location of battery Bat. 3001 on new Synthesizer Module 28141 - 13000.000
