SERVICE LETTER 00003

Subject: Optional removal of F-1054 Tank Attach Angles

Affected Models: RV-10

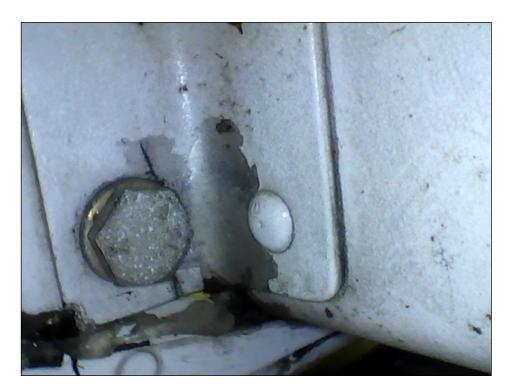
In a number of aircraft, the bottom portion of the F-1054 Tank Attach Angles may crack due to wing deflection (see Figure 1). Analysis, ground testing and flight testing have determined that these angles are unnecessary. Therefore, these parts have been removed from current RV-10 kits.

FIGURE 1: CRACK LOCATION

At the owner's option, installed F-1054 angles (cracked or uncracked) on flying aircraft may either be unbolted and removed, or left in place with no adverse consequences.

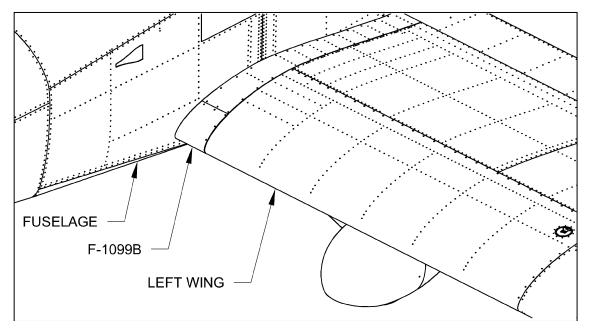
FIGURE 2: LOWER WING ROOT FAIRING

<u>Step 1:</u> Remove enough of the screws from the leading edge of the F-1099B Lower Wing Root Fairings that they can be pulled away from the wing to expose the F-1054-L/R Tank Attach Angles. See Figures 2 and 3.

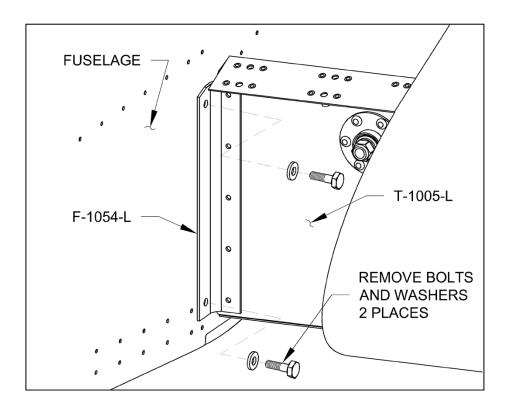
FIGURE 3: REMOVING THE TANK ATTACH ANGLE

<u>Step 2:</u> Remove the two bolts securing the F-1054-L/R Tank Attach Angles to the fuselage. See Figure 3.

<u>Step 3:</u> Center-punch the manufactured heads of the rivets securing the tank attach angles to the T-1005-L/R Tank Attach Brackets, then, using a 12 inch-long #30 drill bit, drill out the rivets. Remove the angles.
