SERVICE BULLETIN SB-00043

Date Released:	September 6, 2023
Date Effective:	September 6, 2023
Subject:	RV-10 & RV-14 elevator skin cracks
Affected Models:	RV-10, RV-14/14A without fuel tank sealant fillets applied to the aft elevator spar
Required Action:	Inspect elevator skins for cracks. If cracks are found, stop-drill and add blind rivets prior to further flight. At or before the next condition inspection, apply fuel tank sealant to interior of skins.
Time of Compliance:	Inspect for cracks before further flight. If cracks are <u>not</u> present, you may continue to comply with this service bulletin via the prescribed inspection no less than every 12 months, or you may complete the modifications described in this service bulletin for aircraft without cracks. If cracks <u>are</u> present: before further flight, stop drill the cracks and install additional rivets. At or before the next condition inspection, and apply fuel tank sealant to the interior of the elevator skins.

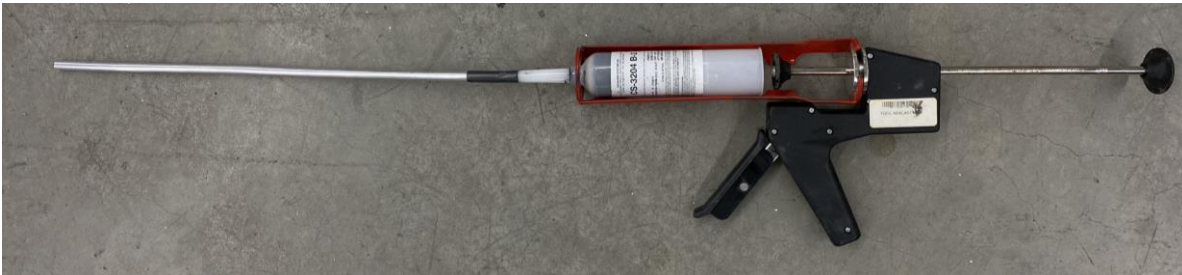
Step 13: Insert the cut end of the nozzle into the end of the aluminum tube, then attach them using strong tape such as duct tape or packing tape. See Figure 8.

NOTE: For Step 14, we recommend using the “Tool Sealant Gun”, available on the Van’s Aircraft web store. See Figure 8.

FIGURE 8: SEALANT GUN WITH 3/8 ALUMINUM TUBE ATTACHED WITH TAPE TO NOZZLE OF MC-236-B1/2 FUEL TANK SEALANT CONTAINER

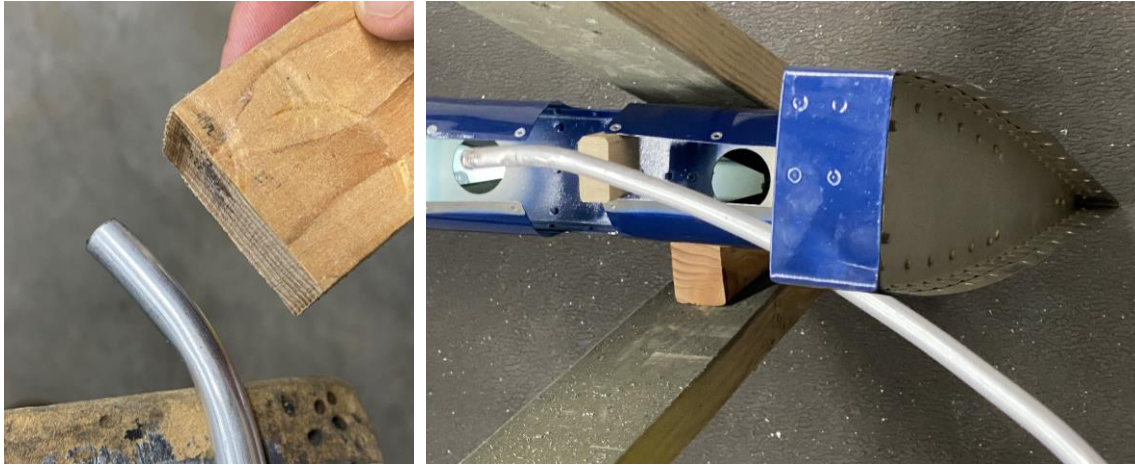
NOTE: For Step 14, bending the tip of the tube can help the placement and shape of the sealant fillet. We recommend a bend of 20 to 30 degrees, 1 in. [25.4 mm] from the tip. For getting around the counterbalance extensions at the tips, bend the entire tube into a wide arc. See Figure 9.

FIGURE 9: BENDING THE TUBE
